# Preliminary Jurisdictional Determination Report

AT DUBLIN DEVELOPMENT PROJECT (APNs: 985-52-25, 985-52-24, 985-51-6, 985-51-5) DUBLIN, ALAMEDA COUNTY, CALIFORNIA

April 2018

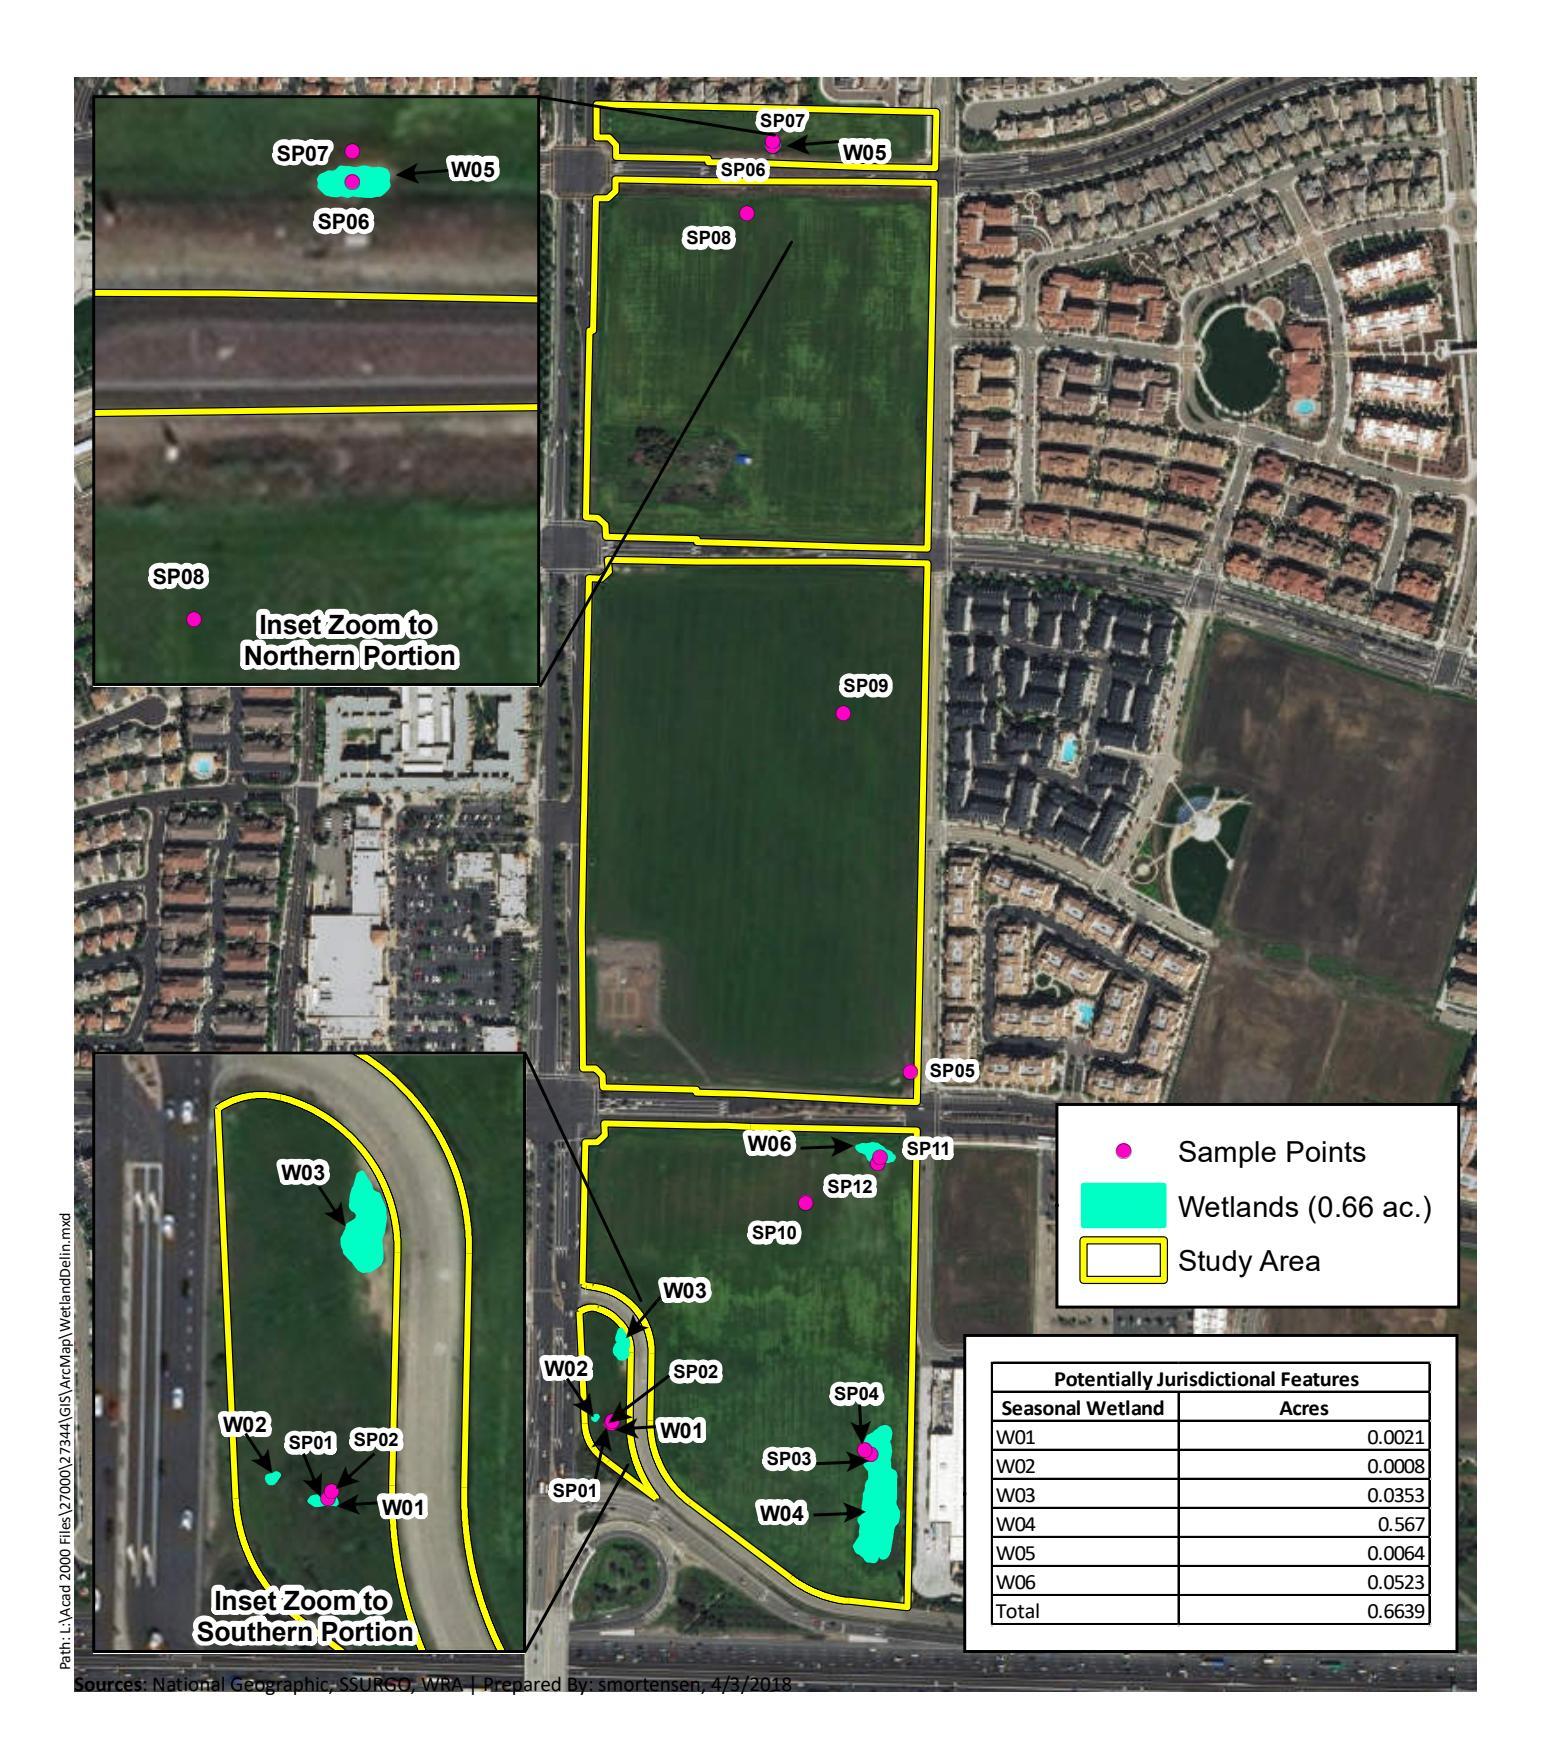
**Appendix A - Preliminary Jurisdictional Determination**

Potential Section 404 and 401 jurisdictional areas are summarized in Table 1 – Summary of Potential Jurisdictional Features within the Project Area and are depicted in Appendix A. Vegetation, soils, and hydrology data collected during the delineation site visit are reported on standard Corps Arid West wetland delineation data forms, which are included in Appendix B. Photographs of representative portions of the Project Area and sample points are shown in Appendix C. A list of all plant species observed during the site visit is included in Appendix D.

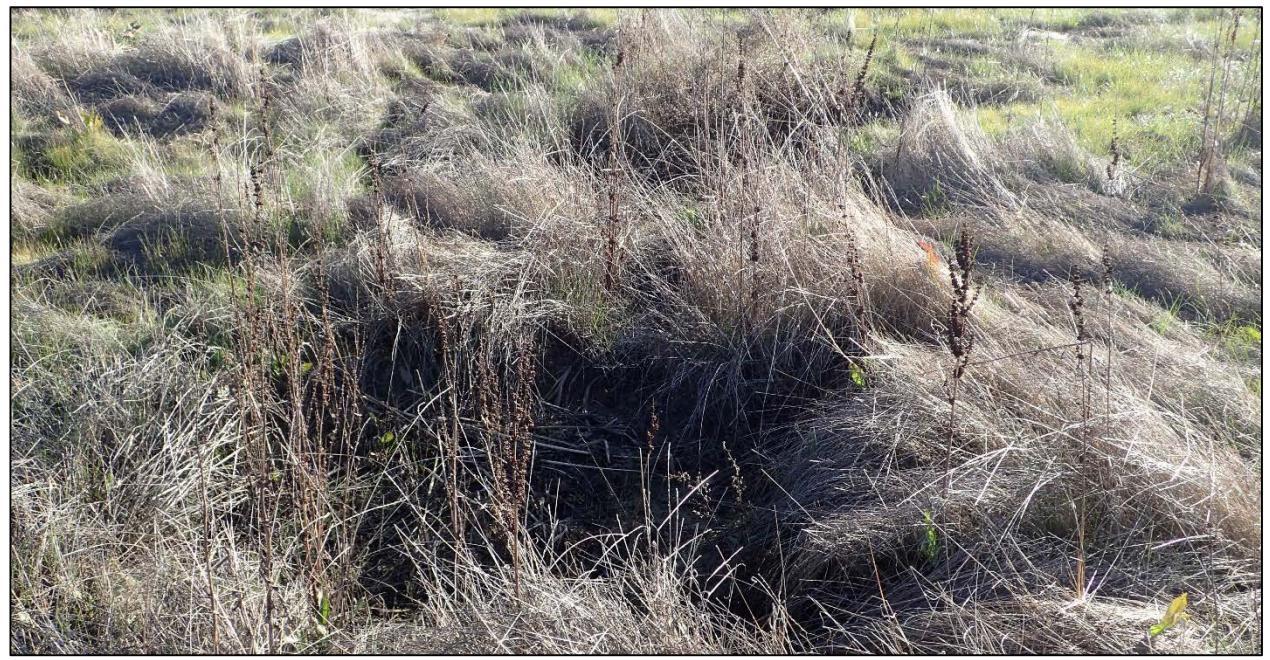
**Photograph 1.** Image shows seasonal wetland W01, in the southwestern portion of the Project Area. View facing east. Photograph taken February 22, 2018.

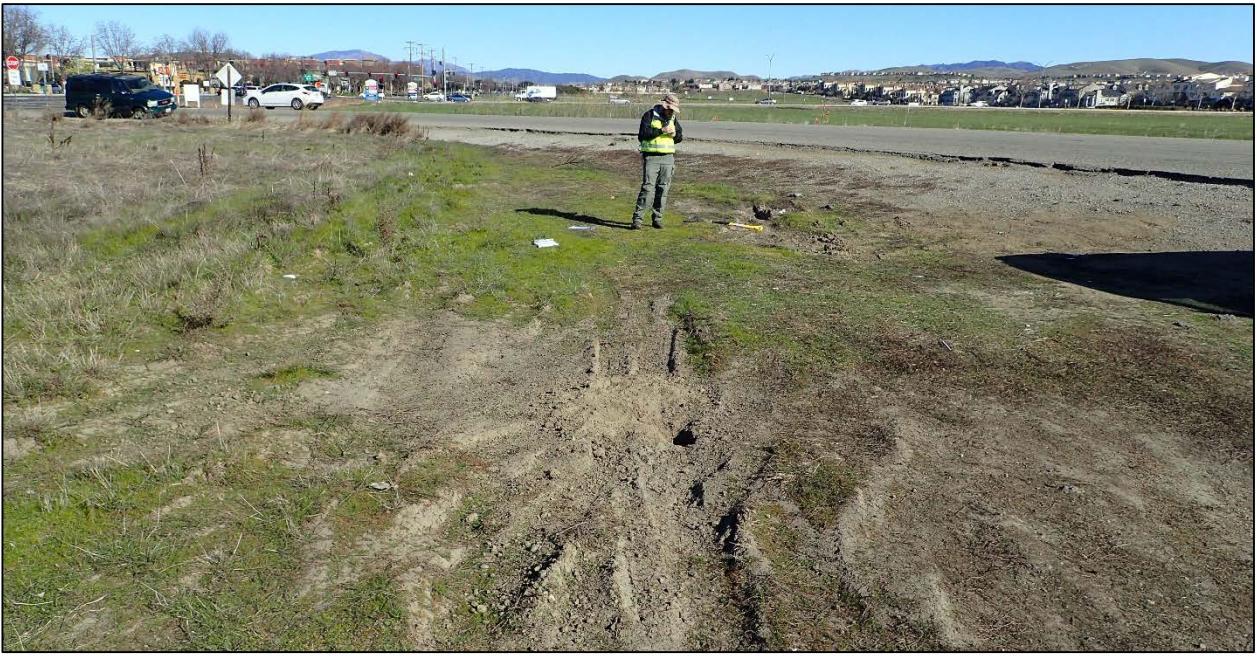
**Photograph 2.** Image shows seasonal wetland W03, located adjacent to the west of Northside Drive, in the southwestern portion of the Project Area. View facing north. Photograph taken February 22, 2018.

W03 is located adjacent to Northside Drive in a ruderal area with compacted soil where vehicles regularly drive through and/or park. Based on analysis of historic aerial imagery (Google Earth 2018, Nationwide Environmental Title Research [NETR] 2018), this feature does not appear to be a remnant of the historic, unaltered topography, but rather the result of anthropogenic disturbance. Here, the vegetation was dominated by non-native species, such as Italian ryegrass and hyssop loosestrife, though stipitate popcornflower (*Plagiobothrys stipitatus*) was present at low cover. Upland, non-native annual species, such as slim oat and black mustard, were encroaching on all sides of the feature.

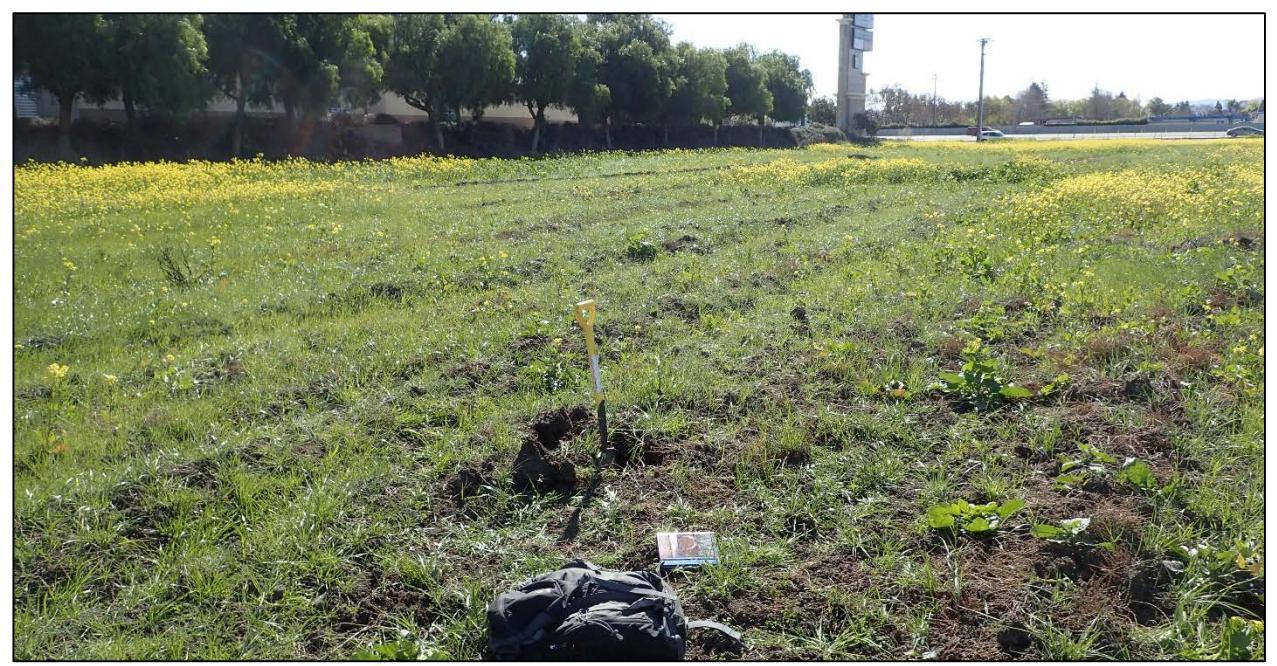
**Photograph 3.** Image shows seasonal wetland W04, located in the southeastern corner of the Project Area. View facing south. Photograph taken February 22, 2018.

W04, located in the southeast corner of the Project Area, is a broad, shallow depression that forms where site drainage backs up against the berm and wall along the eastern boundary of the Project Area. The feature is disced as part of annual sitewide fuel reduction activity. W04 was dominated by non-native annual forbs such as Italian ryegrass, hyssop loosestrife, and bur clover (*Medicago polymorpha*; FACU). Few native species were present, including Congdon's tarplant (*Centromadia parryi* ssp. *congdonii*; FACW) and at very low cover, stipitate popcornflower.

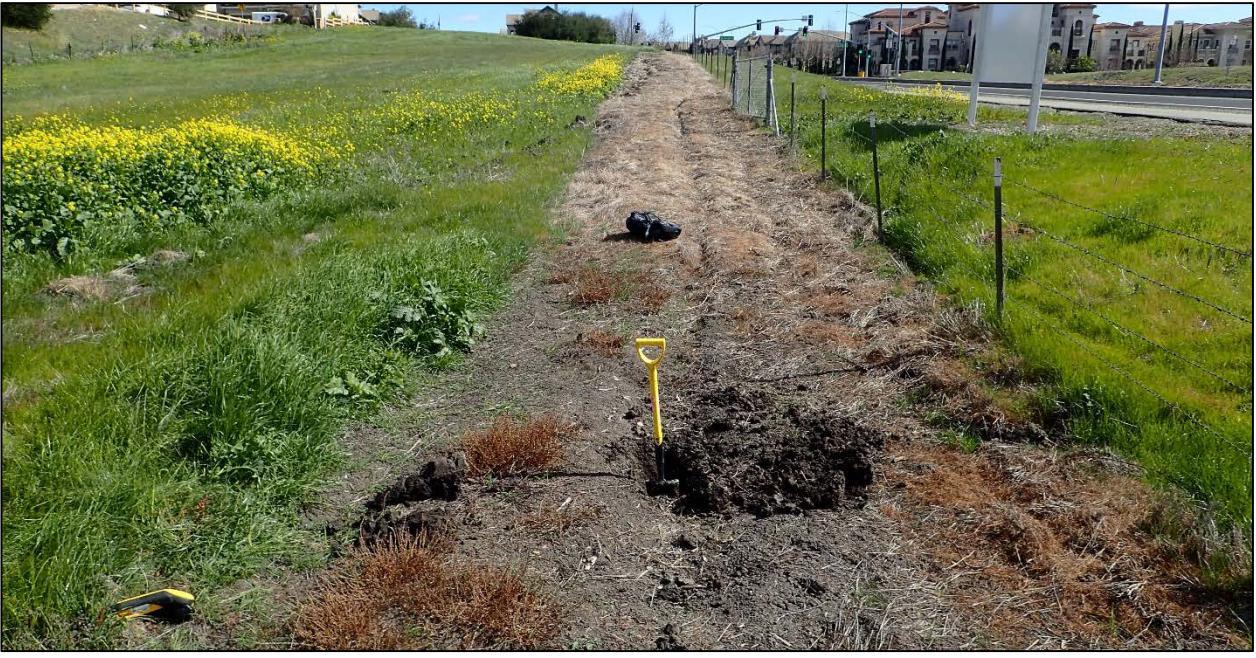
**Photograph 4.** Image shows seasonal wetland W05, located at the base of the road bank on the north side of Gleason Drive in the northern portion of the Project Area. View facing east. Photograph taken February 22, 2018.

W05 is a small, shallow depression situated in a low spot where water collects at the base of the Gleason Drive road embankment. The feature is disced as part of annual sitewide fuel reduction activity, and it is located in a strip of land bordering the fenceline that appears to have been treated with herbicide. Here, the vegetation was sparse and was dominated by hyssop loosestrife and Italian ryegrass.

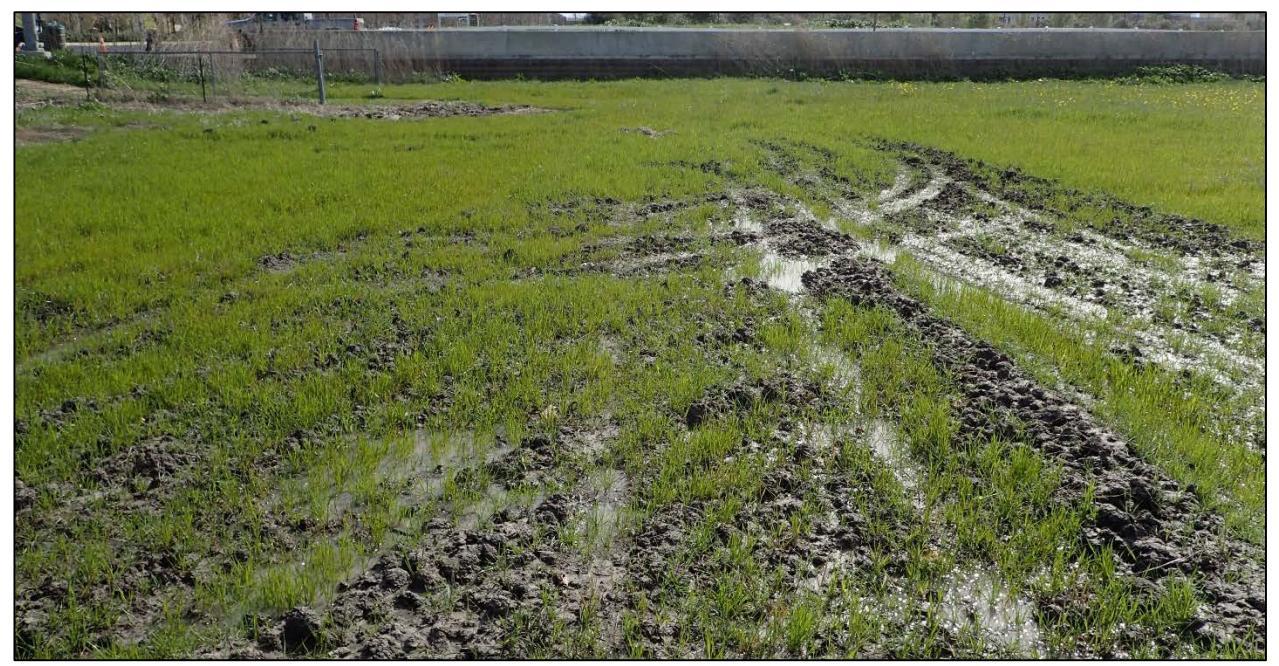
**Photograph 5.** Image shows seasonal wetland W06, a flat to slightly sloping area of whitish clay. View facing east. Photograph taken March 19, 2018.

W06 is a small, flat-to-gently-sloping area of whitish clay soils located southwest of the Dublin Boulevard and Barrington Street intersection. This area is disced as part of annual sitewide fuel reduction activity. Vegetation in this feature is sparse and dominated by Italian ryegrass, though scattered individuals of hyssop loosestrife, stipitate popcornflower and woolly marbles (*Psilocarphus* oregonus; OBL) are present.

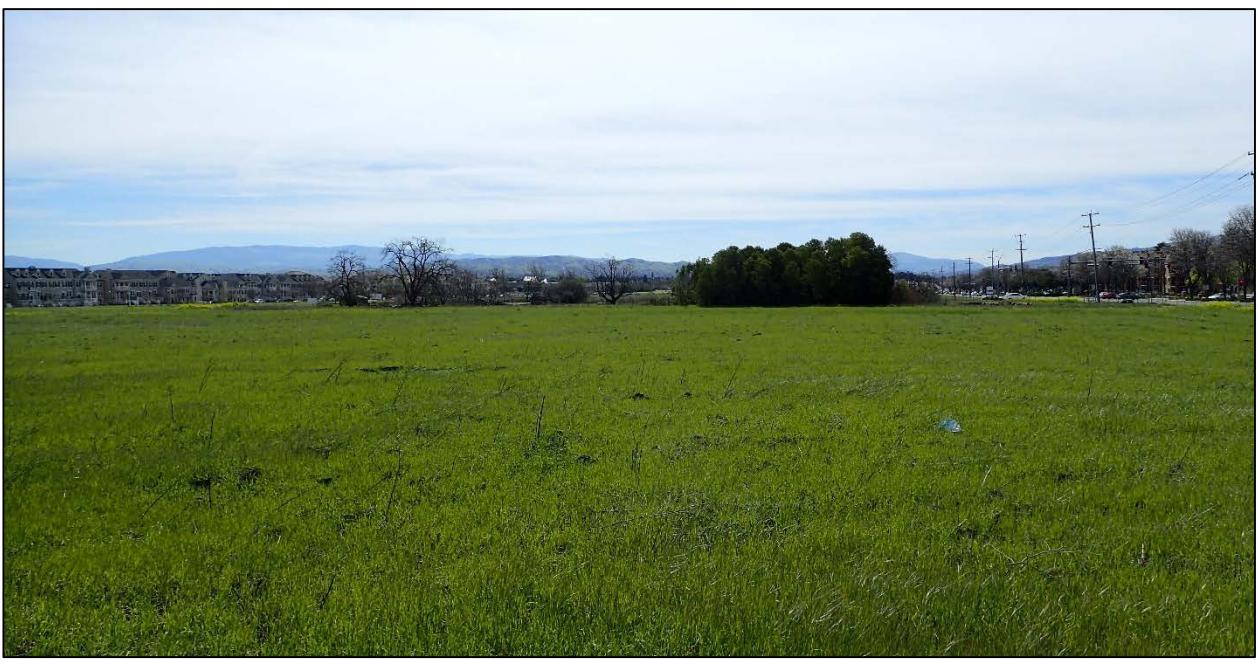
**Photograph 6.** Image shows ruderal grassland in the northern portion of the Project Area, with the former homestead location visible in the background. Image is representative of upland areas in the Project Area. View facing south. Photograph taken March 19, 2018.
